NUMBER: 03-003-02 REV. A

GROUP: Rear Axle

Rear Axle Whine Sound

1999-2001 (WG/WJ) Jeep Grand Cherokee

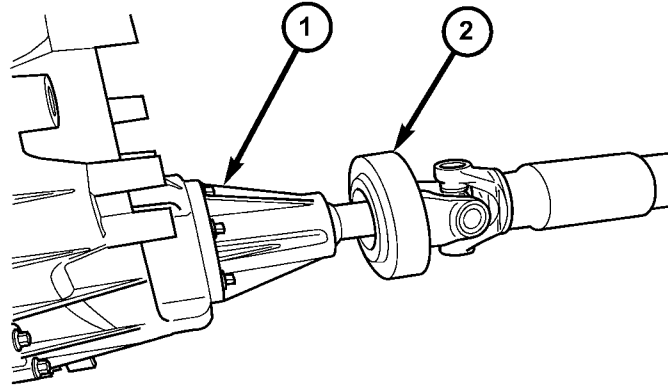
Fig. 1 DAMPER LOCATION

Customer may complain of a high-pitched sound coming from the rear of the vehicle between 55 and 70 MPH (88 - 112 KPH)

If the customer complains of the condition, and the damper is not present, perform the repair.

This bulletin involves installation of a new rear propeller shaft with a damper on the front yoke.

Follow the removal and installation procedures in Section 3 of the appropriate service manual for the model year under "Propeller Shaft - Rear". Refer to (Fig. 1) below for the location of the damper.
