NUMBER: 07-005-02

GROUP: Cooling

Newly Released Solenoid For DTC P1499 - Hydraulic Fan Solenoid Circuit Fault

- 2001 - 2004 (WJ) Grand Cherokee
- 2001 - 2004 (WG) Grand Cherokee (International Markets)

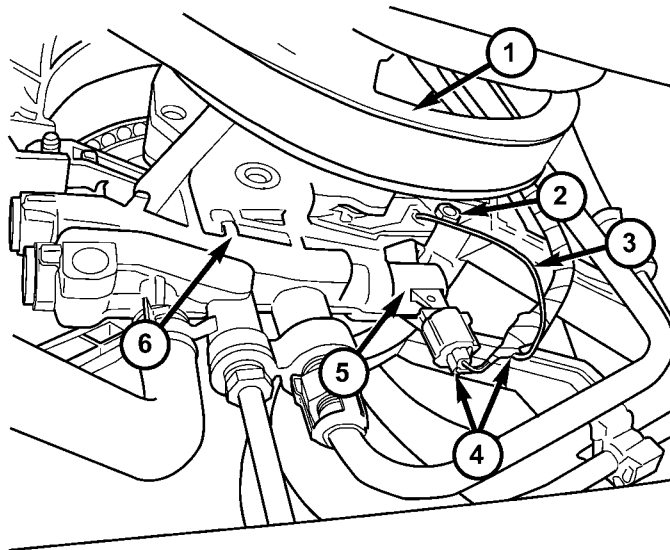
Fig. 1 HYDRAULIC FAN MODULE / SOLENOID

The customer may experience a MIL illumination due to DTC P1499 - Hydraulic Fan Solenoid Circuit. The MIL illumination may occur intermittently.

1. With the engine off, disconnect the negative battery cable from the negative battery terminal.
2. Raise the vehicle on a suitable lift.
3. Clean the immediate area around the hydraulic fan solenoid of any debris.
4. Disconnect the electrical harness from the hydraulic fan solenoid (Fig. 1).

NOTE: IF FOR ANY REASON DURING THE REPAIR PROCEDURE THE ELECTRICAL GROUND WIRE IS REMOVED FROM THE HYDRAULIC FAN MODULE ASSEMBLY, THEN RECONNECT THE GROUND WIRE AND TIGHTEN THE RETENTION NUT TO 10 NM (7.4 FT. LBS.). FAILURE TO ENSURE THE GROUND STRAP IS PROPERLY CONNECTED COULD RESULT IN ELECTROSTATIC DISCHARGE THAT MAY DAMAGE THE PCM.
