Technical Service Bulletin

NUMBER: 08-22-00 Rev A

4.7L Camshaft Position Sensor Contacts Tone Wheel

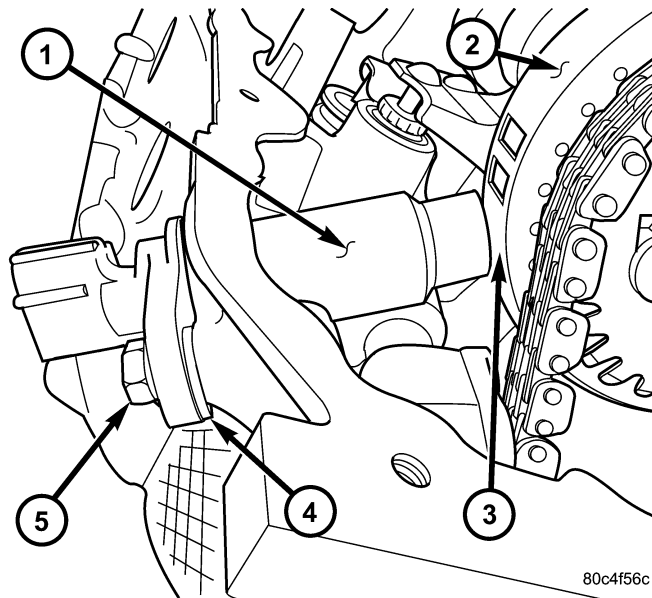
FIGURE 1

The camshaft position sensor may make contact with the tone wheel because the pad on the cylinder head, which the CMP attaches to, was over-machined.

A technician making repairs in the area of the CMP sensor may overlook or lose the previously installed shim. This may then cause the camshaft position sensor to contact the tone wheel when the CMP sensor is reinstalled or replaced.

- 1 - Cam Position Sensor (CMP)
- 2 - Tone Wheel
- 3 - Air gap (.030 in. +/- .010 in.)
- 4 - Select fit shim used to adjust air gap
- 5 - CMP sensor mounting bolt

1. Observe how the cam position sensor is mounted to the engine cylinder head. Inspect for the presence of a shim between the CMP sensor and the engine cylinder head. Figure 1.

-
6. If there is evidence of damage to the CMP sensor, due to contact with the tone wheel, then the correct amount of air gap between the CMP sensor and tone wheel must be verified.
 7. Remove the right engine cylinder head cover and gasket. Refer to the 2000 model year WJ Service Manual – Group 9 (Engine) page 97 for additional technical assistance.

- 8. Install a new cam position sensor to the engine cylinder head. Refer to the 2000 model year WJ Service Manual – Group 8D (Electrical Ignition) page 18 for additional technical assistance. Make sure the CMP sensor is full seated. The mounting bolt may be used temporarily to hold the CMP sensor in place and tight against the pad on the engine cylinder head.
- 9. If necessary, use the appropriate select fit shim (p/n 05019089AA) to adjust the air gap between the cam position sensor and the tone wheel so that an air gap of 0.76 mm +/- 0.25 mm (.030 in. +/- .010 in.) is achieved. Note that an air gap of 0.76 mm (.030 in.) is preferred.
- 10. Install and tighten the cam position sensor mounting bolt to 12 Nm (106 in. lbs.). Connect the wire harness terminal to the cam position sensor.

- 11. Verify the air gap between the cam position sensor and the tone wheel is correct.
- 12. Clean and inspect the engine cylinder head cover gasket and mating surfaces.
