NUMBER: 23-015-03

Wind-Like Sound At Top Rear Corner Of Front Door

1999 - 2004 (WJ/WG) Grand Cherokee (Domestic and International Markets)

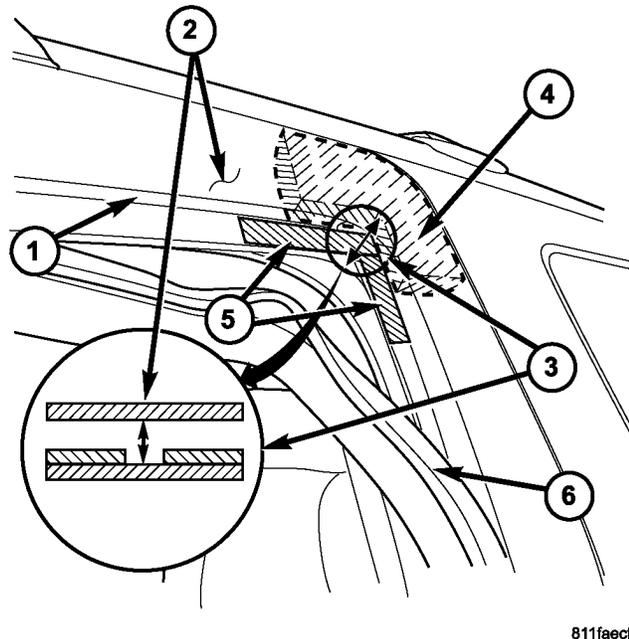
Fig. 1 FRONT DOOR WINDOW FRAME CHANNEL

2. Remove a sufficient amount of the window run channel weatherstrip from the window channel in order to gain access to the top rear corner of the window frame channel.
3. Check for the presence of a "L" shaped foam stuffer. The foam stuffer is located in the top rear corner of the door frame and behind the vertical and horizontal metal inserts of the window frame channel. Install a new foam stuffer if missing.
4. Verify that the foam stuffer is correctly positioned into the corner of the window frame with each end of the foam stuffer extending behind the vertical and the horizontal channel inserts. The foam stuffer should not be "balled up". When properly installed, the foam stuffer should restrict the flow of air inside the window frame. (Fig. 1)

- 1 - Window Channel
- 2 - Outer Door Panel
- 3 - Measure Here - 21 mm (0.826 in) maximum width
- 4 - "L" Shaped Foam Stuffer - Verify Correct Position
- 5 - Foam Tape - Install at two locations to inner door panel
- 6 - Window Run Channel Weatherstrip

5. At the top rear corner of the window frame channel, measure the width (distance) between the inside surfaces of the inner and outer door panels. Do not include the angled metal channel insert in your measurement.
6. The desired window channel width at the top rear corner is **19.6 mm +/- 1.5 mm (allowable width of 18 to 21 mm)**.
7. If the inside width of the window channel at the top rear corner is greater than **21 mm (0.826 in.)**, then add a 63.5 mm (2½ in.) long by 1.8 mm (0.060 in.) thick strip of foam tape to the vertical and to the horizontal surfaces of the window channel inner panel.
8. If the inside width of the window channel at the top rear corner is greater than **22.5 mm (0.886 in.)**, then a second layer of foam tape may need to be applied on top of the first vertical and horizontal layer of foam tape.

- 9. Install the window run channel weatherstrip.
- 10. Raise the window glass and verify correct window operation.
