NUMBER: 23-027-04

Flutter-Like Sound From Outside Mirror During High Vehicle Speeds

1999 - 2004 (WG) Grand Cherokee (International Markets Only)

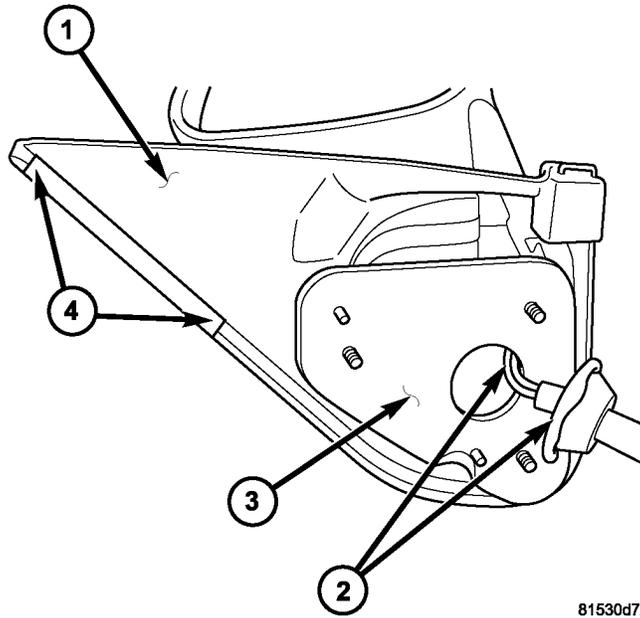
Fig. 1 OUTSIDE MIRROR - BACKSIDE VIEW

The customer may experience a flutter-like sound when traveling at vehicle speeds of 80 km/h (50 mph) or higher coming from the area of the outside mirror. The flutter-like sound may be caused by a vibration of the plastic base (flag) section of the outside mirror assembly against the outer door panel.

- 1 - PLASTIC BASE (FLAG) SECTION OF OUTSIDE MIRROR
- 2 - POWER MIRROR HARNESS AND SEALING GROMMET
- 3 - MIRROR BASE (FLAG) SEAL
- 4 - DOUBLE COATED FOAM TAPE INSTALL LOCATION

1. Remove the front door trim panel.
2. Disengage the outside power mirror harness connector, if equipped.
3. Remove the mirror flag seal.
4. Remove the nuts attaching the mirror to the door.
5. Separate the mirror from the door.
6. Clean the back side of the mirror base (flag) in the area where the double-coated foam tape will be applied (Fig. 1).
7. Install a 90 mm x 9 mm x 1.14 mm (3.5 in x 0.35 in x 0.045 in) piece of double-coated foam tape to the back side of the mirror base.

- 8. Position the mirror to the outer door panel. Verify that the gasket seal is properly positioned.
- 9. Install the attaching nuts and tighten to 7 Nm (60 in. lbs.).
- 10. Install the mirror flag seal.
- 11. Engage the power mirror harness connector, if equipped.
- 12. Install the door trim panel.
- 13. Verify proper mirror operations
