# Technical Service Bulletin

**NUMBER:** 23-30-00

Front seat belts may be slow to retract.

1999 - 2000 (WJ) Grand Cherokee

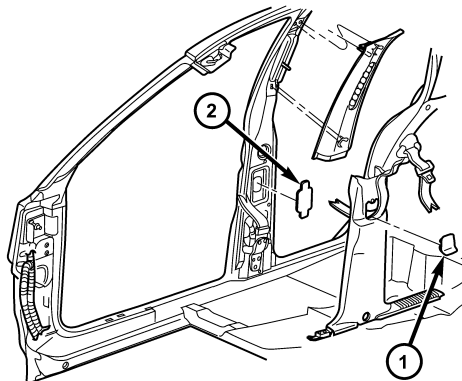
**FIGURE 1**

The seat belt webbing may come in contact with the wire harness causing the belt to retract slowly.

Remove the seat belt access cover from the B Pillar trim panel and inspect the seat belt for contact with the wire harness (See Figure 1). If contact is evident, perform the Repair Procedure.

1. Access Cover
2. Shield

1. Remove the B Pillar trim panel (See Figure 1).

2. Install the shield, p/n 55116545AB, into the opening by inserting the tabs one at a time.
3. Install the trim panel
